DEPARTMENT OF TRANSPORTATION

Contract #: 04-0120F4Cty: SF/ALA Rte: 80 PM: 13.2/13.9File #: 69.28**WELDING INSPECTION REPORT****Resident Engineer:**Pursell, Gary**Address:** 333 Burma Road**City:** Oakland, CA 94607**Report No:** WIR-004355**Date Inspected:** 08-Oct-2008**Project Name:** SAS Superstructure**OSM Arrival Time:** 700**Prime Contractor:** American Bridge/Fluor Enterprises, a JV**OSM Departure Time:** 1700**Contractor:** Zhenhua Port Machinery Company, Ltd (ZPMC), Changxing Island **Location:** Shanghai, China**CWI Name:** Sun Wei**CWI Present:** Yes No**Inspected CWI report:** Yes No N/A**Rod Oven in Use:** Yes No N/A**Electrode to specification:** Yes No N/A**Weld Procedures Followed:** Yes No N/A**Qualified Welders:** Yes No N/A**Verified Joint Fit-up:** Yes No N/A**Approved Drawings:** Yes No N/A**Approved WPS:** Yes No N/A**Delayed / Cancelled:** Yes No N/A**Bridge No:** 34-0006**Component:** Tower**Summary of Items Observed:**

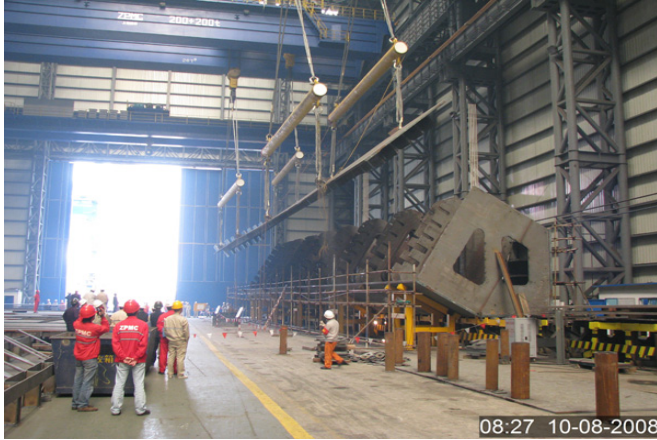
South Shaft, Skin E, Lift 1

The Quality Assurance Inspector observed ZPMC where ZPMC had performed base metal build up of strut windows on the South Shaft, Skin E, lift 1. It appears there was damage made to the base metal during cutting operations. Below is a digital photograph illustrating the repair made.
